Western Reserve Home Inspection LLC

Address of house:

Age of house: Built in 1925; the house is 84 years old.

Type of house: 2 story wood frame.

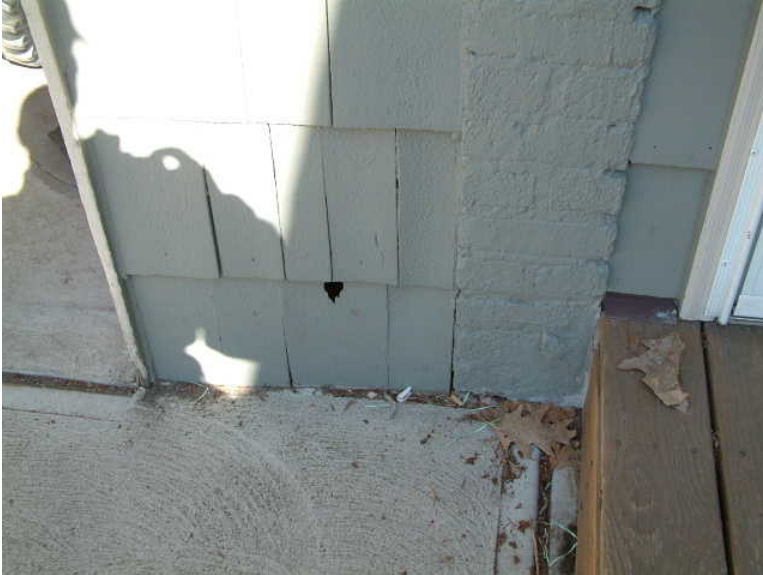
The picture below shows a hole in the shingles at the ground near the garage vehicle door opening. I recommend this shingle should be replaced.

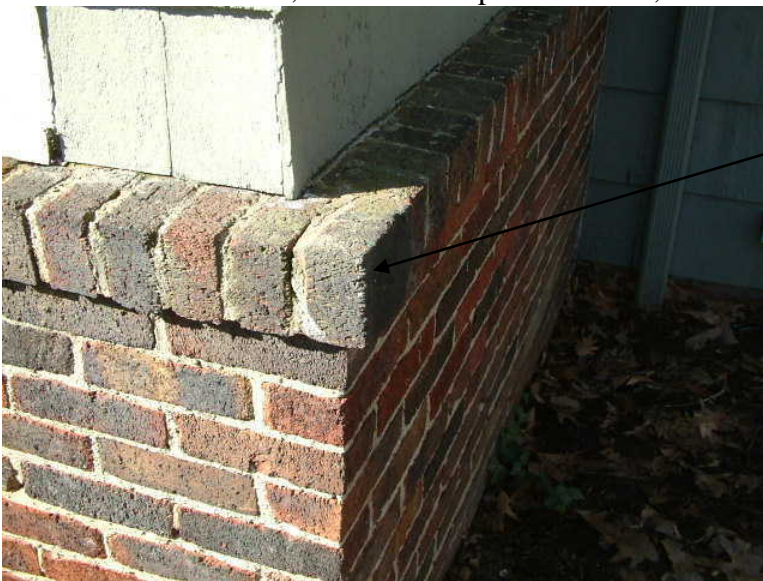
The fired clay brick masonry wall around the front entryway is in generally good condition. However, the brick at the corner of the sill, shown in the picture below, is loose and needs to be reset on fresh mortar.

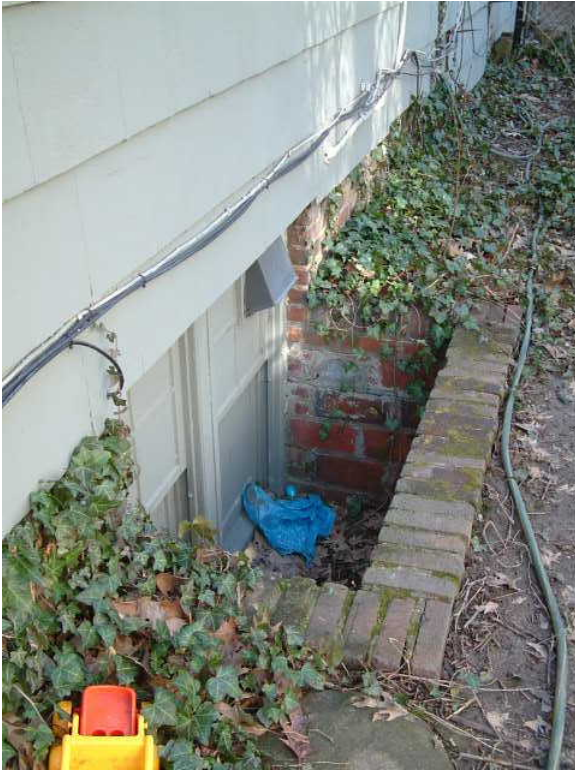
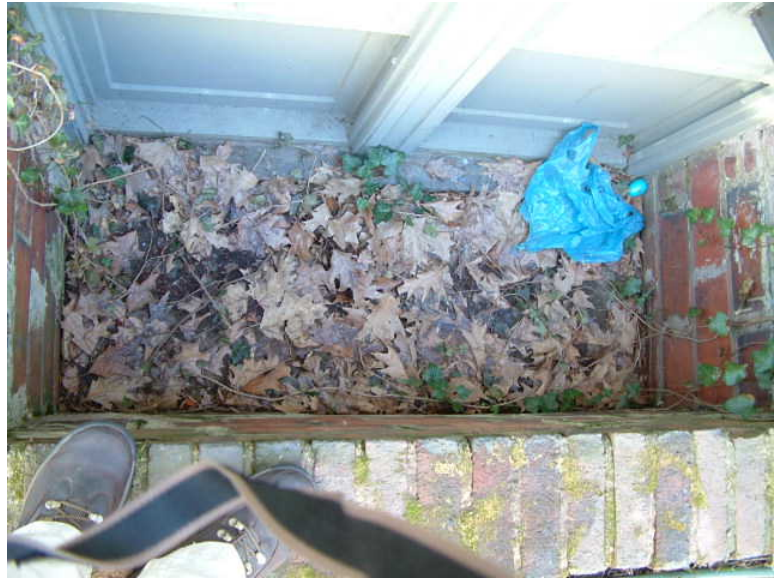
The two pictures below show the window well on the northwest face of the house. The masonry walls are in fair condition. Cracking was seen in the masonry but it does not need to be repaired at the time of inspection. The right side picture below shows leaves and debris at the bottom of the well. I recommend that this should be cleaned and that the drain at the bottom of the well should be cleaned. Grating that can hold the weight of a person should be installed over this opening to prevent accidental falls. A competent and qualified masonry contractor or metal work contractor can do this work.

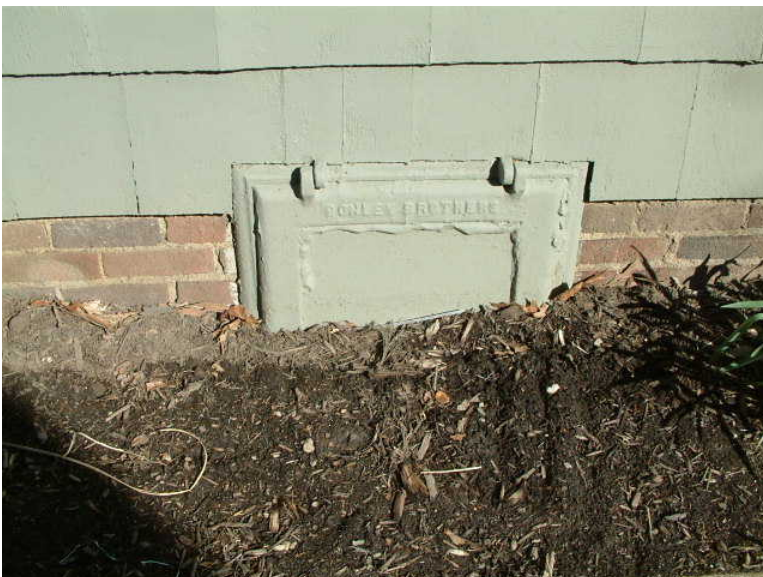
The picture above shows the old coal chute door on the southeast face of the house. I recommend it should be replaced with brick masonry or glass block masonry. Also, see the basement discussion.

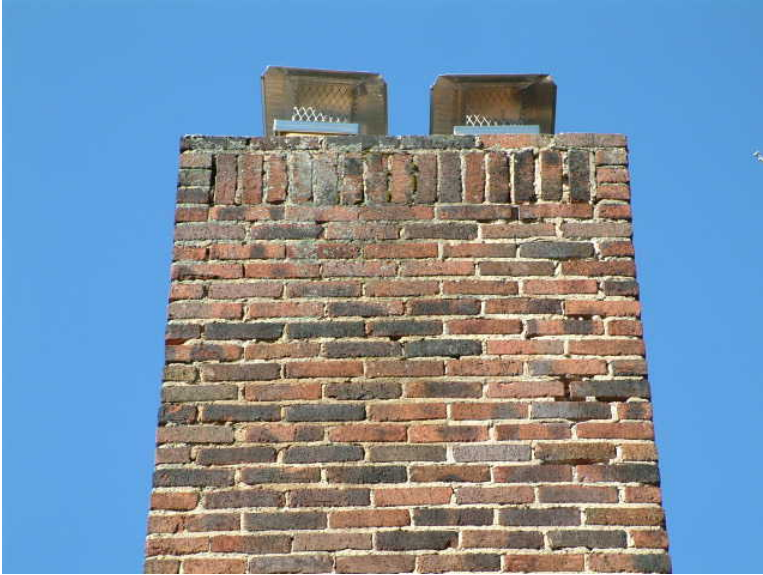
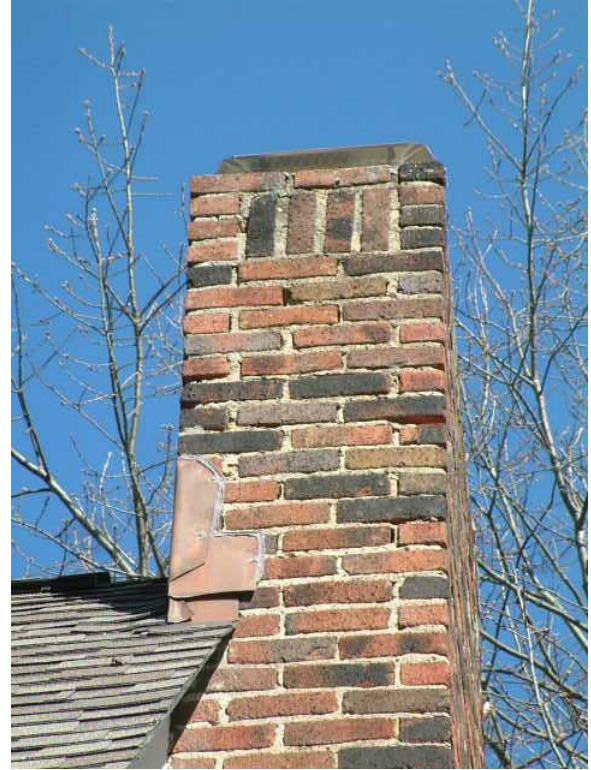
Chimneys: The chimneys are built of fired clay brick masonry. They are in good condition except at the top of the fireplace chimney where minor tuck pointing is needed to fill gaps in the mortar as shown in the two pictures below. A competent and qualified masonry contractor or chimney repair contractor can do this work.

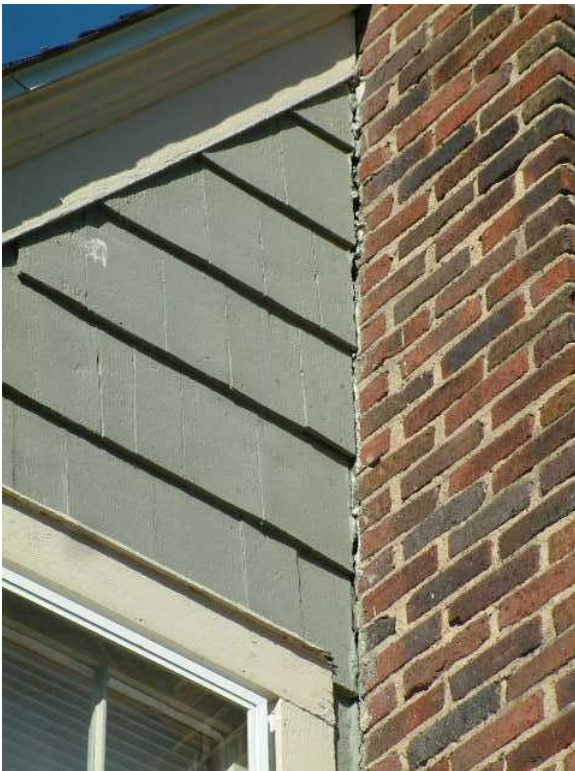
The picture above shows a gap between the siding and the masonry of the chimney on the northeast face of the house. I recommend that this should be sealed with caulking or a strip of wood to close the gap between the wood siding and masonry. This will help keep birds and bats out of the attic. A competent and qualified siding contractor can do this work.

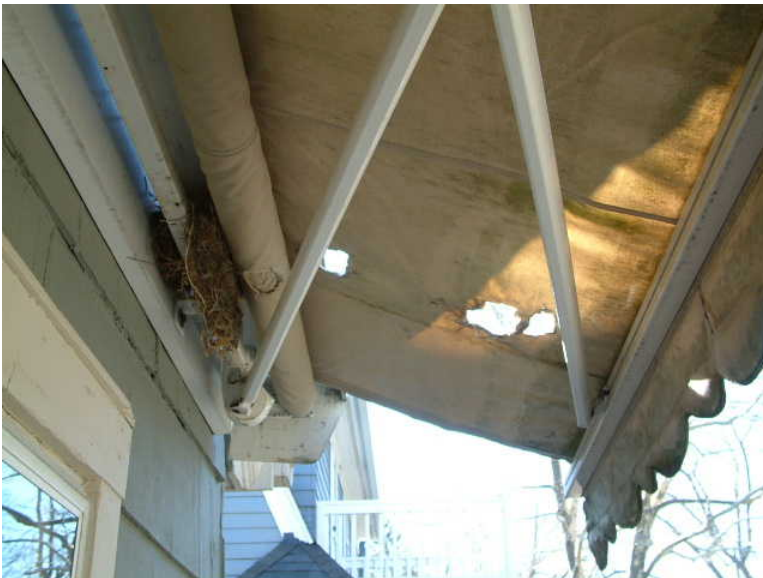
The picture above shows the canvas awning over the deck. The awning mechanism is in good condition and operates smoothly and easily. However, the awning needs to be replaced. It has been damaged by weather and birds nesting in the mechanism.

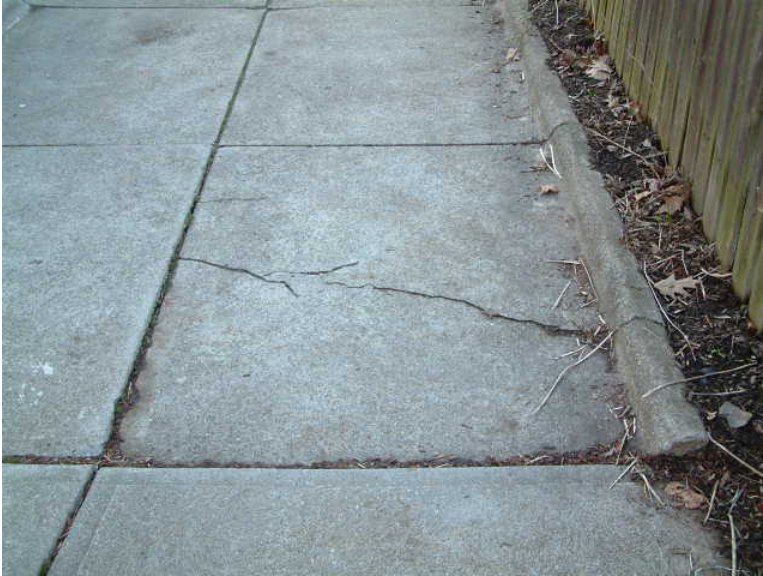
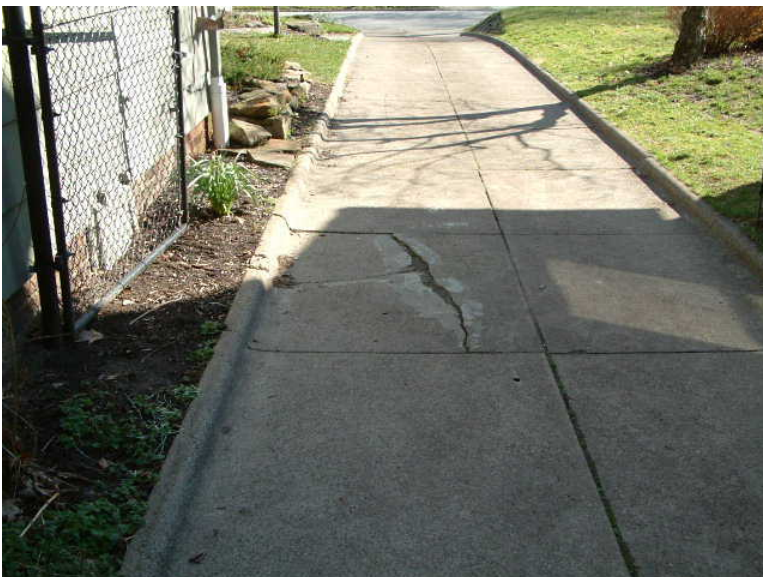
Driveways: The driveway is concrete. It is in generally good condition except at the two sections that are cracked shown in the two pictures below. The driveway is serviceable. The city of Shaker Heights will likely require breaking up the two cracked sections and replacing them.

I recommend filling the joints between slabs with good quality, exterior grade caulk or flexible concrete joint filler. The caulk or joint filler should have ultraviolet light resistance. Filling the joints will help prevent water from seeping underneath the slabs and freezing during the winter, which will cause heaving and cracking. I recommend that the use of de-icing salts should be limited to help prevent damage to the concrete surface.

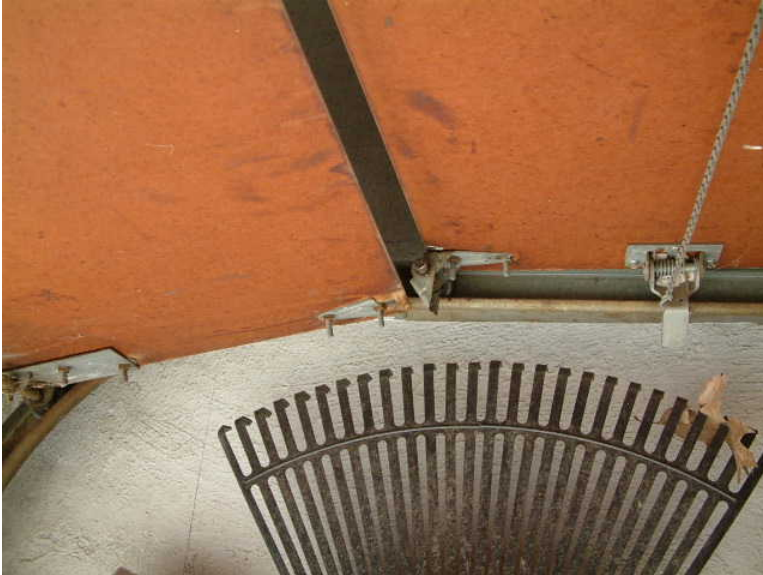
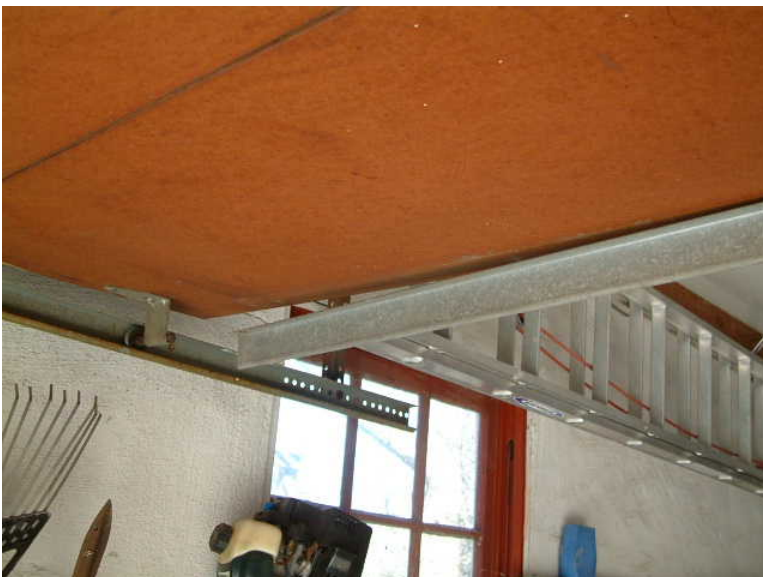
The vehicle door is a wood composite. It appears to be in poor to fair condition. A broken joint bracket was seen at the west end of the door as shown in the picture below. This needs to be repaired to prevent the door from collapsing.

The upper stiffener rail is loose at the west end of the door. This needs to be properly reattached with screws to prevent the door from cracking.

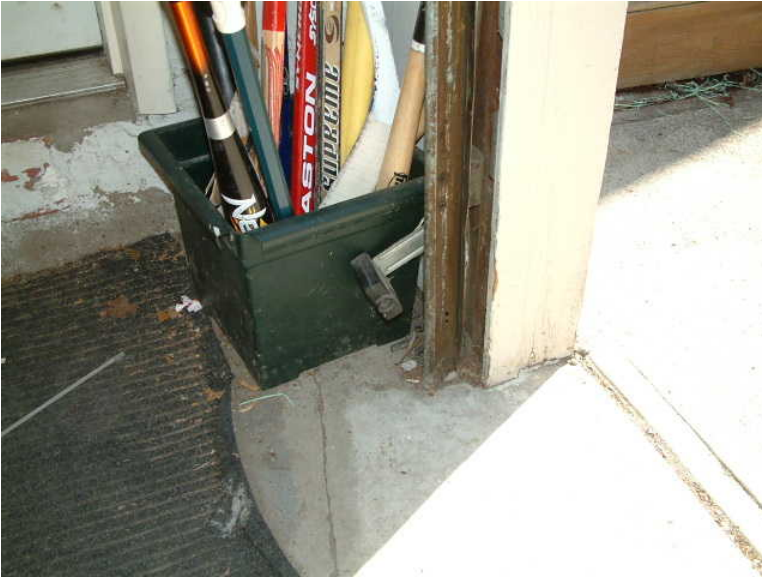
Garage (continued): are in good condition and operating properly. However, the East electric eye mechanism is bent and needs to be properly repositioned.

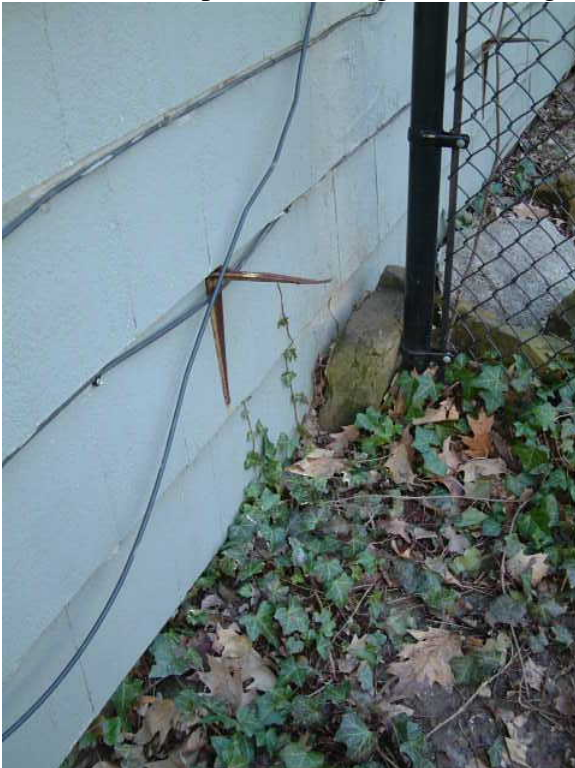
I recommend that ivy and soil against the siding along the northwest wall of a house should be removed and drawn down to prevent rotting of the siding.

Small trees growing near the northwest wall of the house should be cut down and removed.

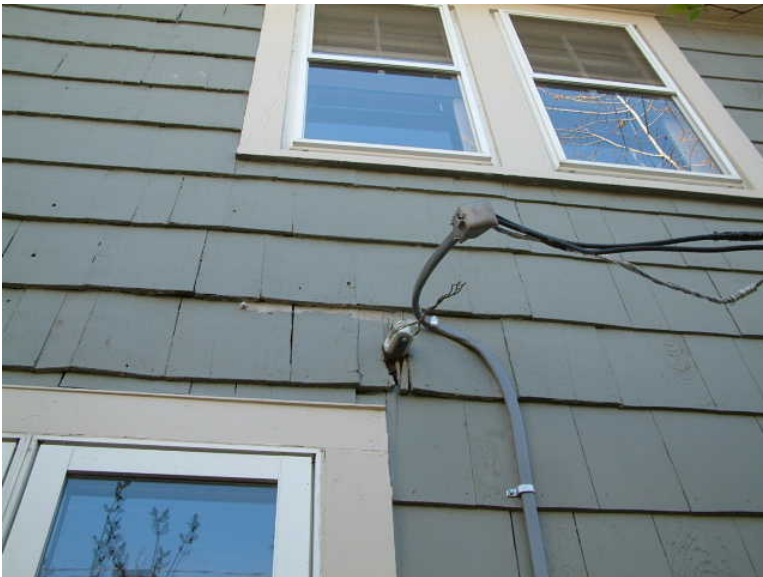
The electric power cables run to the house from a poll at the West corner of the property. The left side picture below shows that the power cable bracket on the house has been torn off the wall; probably during a storm. I recommend this should be firmly reattached to the wall for safety. The electric power utility should be contacted about reattaching this cable.

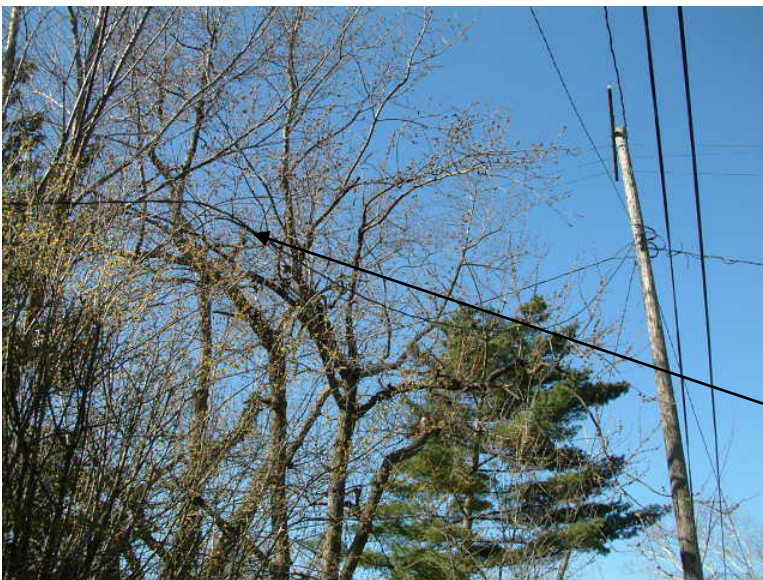
Picture above shows the electric power cables tangled in tree branches along the northwest property line. I recommend that the branches should be trimmed to allow the cable to pass to the house unhindered.

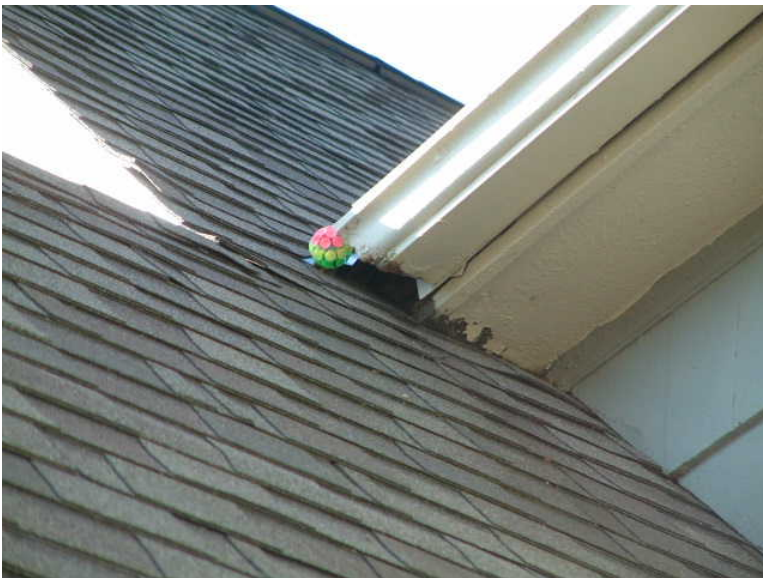
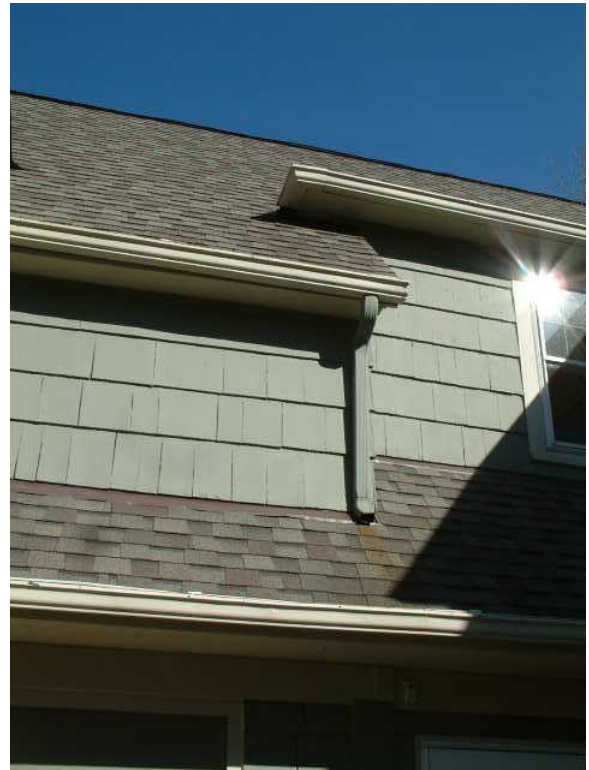
Shingles are a water resistant, not waterproof, covering. Excessive flow of water on the shingles, such as discharge from a downspout or open-ended gutter, can prematurely wear the shingles. I recommend that the open and gutters should be sealed and have downspouts attached to drain directly to the lower gutters. The right side picture below shows an upper downspout that needs an extension to deliver water directly to the lower gutter.

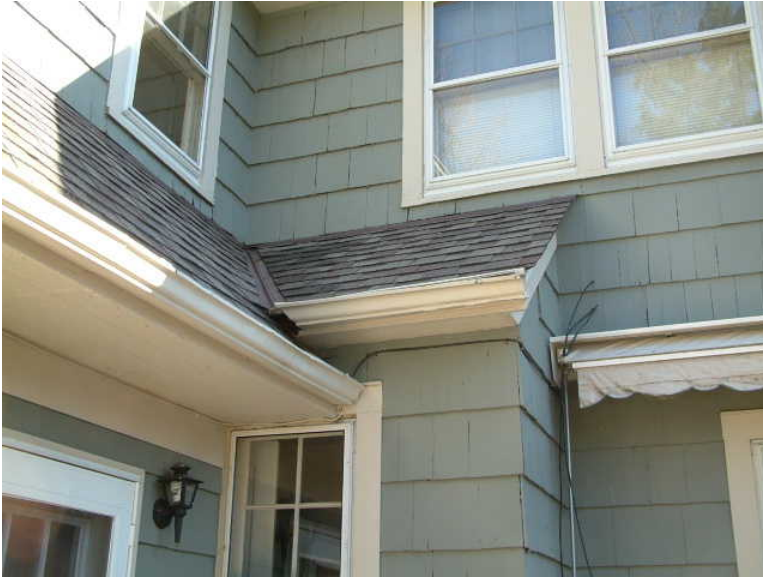
Downspouts/gutters (continued): The short piece of gutter shown in the picture below can be left to drain down the shingles lower gutter.

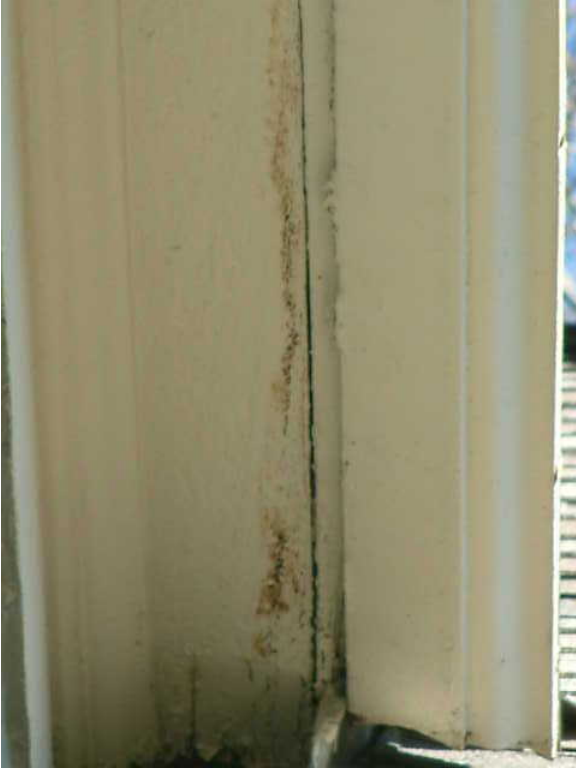
Overhangs/Cornices/Eaves: The eave soffits (underside surfaces of the roof overhangs) are generally well painted and in good condition. However, the picture below shows possible water damage from a clogged gutter that is backing up spilling water behind on to the fascia and into the soffit. This could also be damage from an ice dam during the winter.

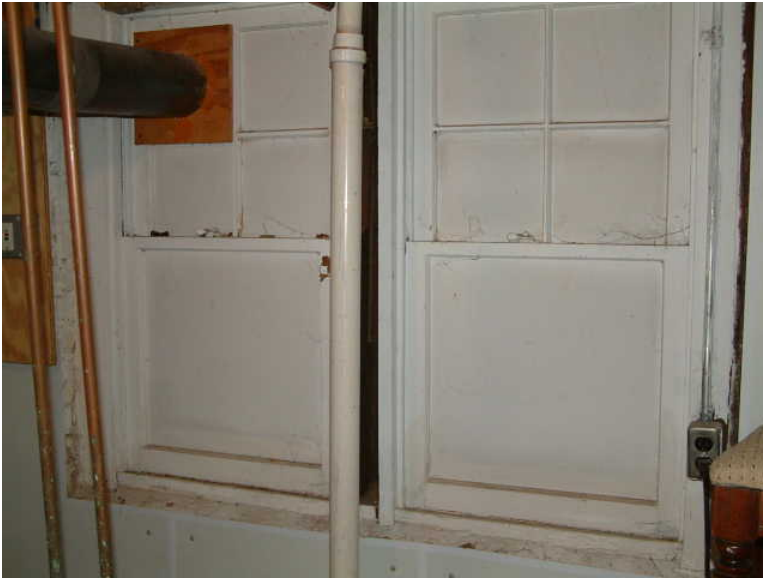
Windows: The picture below shows the Northwest side basement window opposite the window well. I recommend that this window should be replaced with glass block masonry. The duct in the upper left of the picture is the exhaust from the kitchen stove fan.

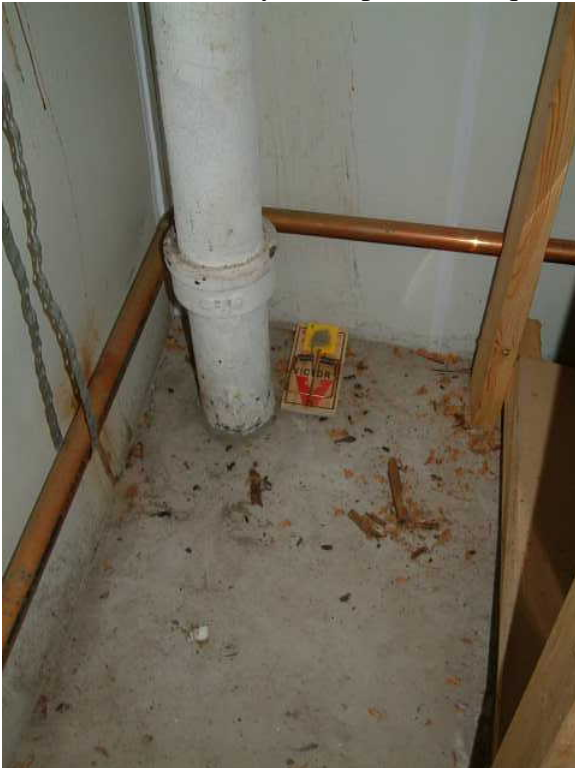
Miscellaneous: The picture below shows a rat trap in the southwest storage room of the basement. This trap is energized and rat droppings were seen on the floor around the trap. I recommend that the House should be treated for rodents by a competent and qualified pest inspector.

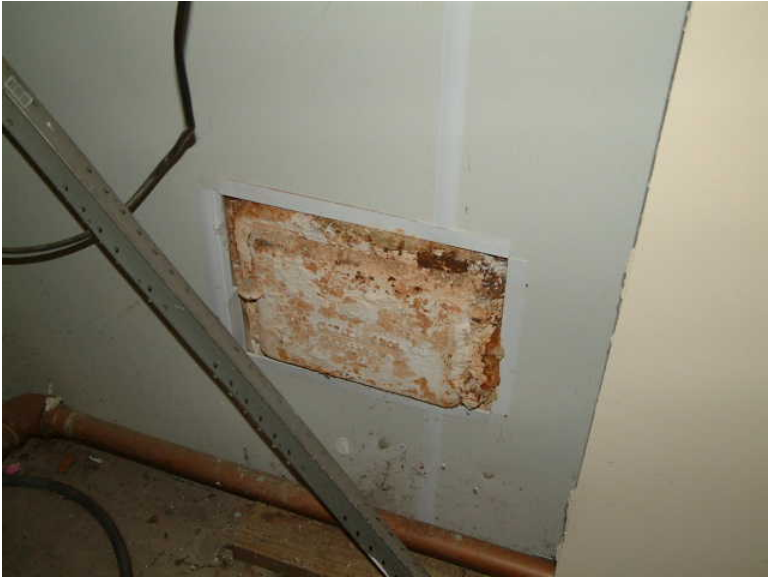
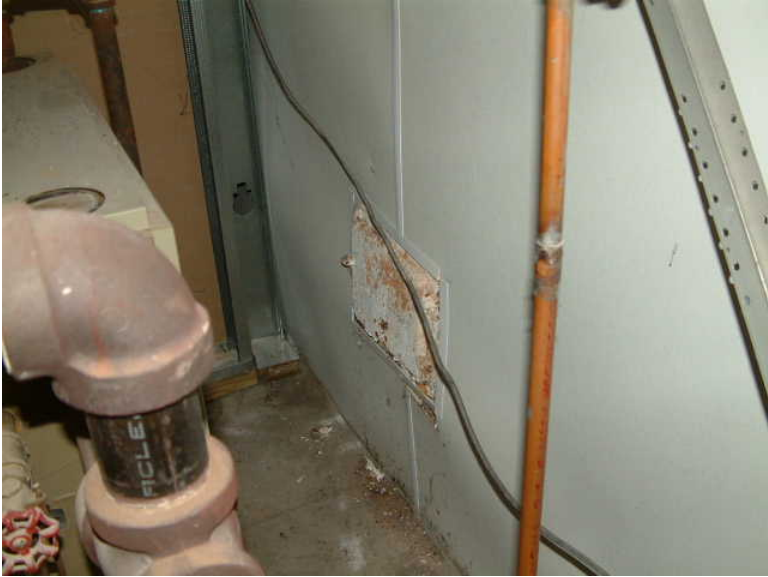
Miscellaneous: The two pictures below show cleanout doors for the ash pit below the fireplace. They are in fair condition.

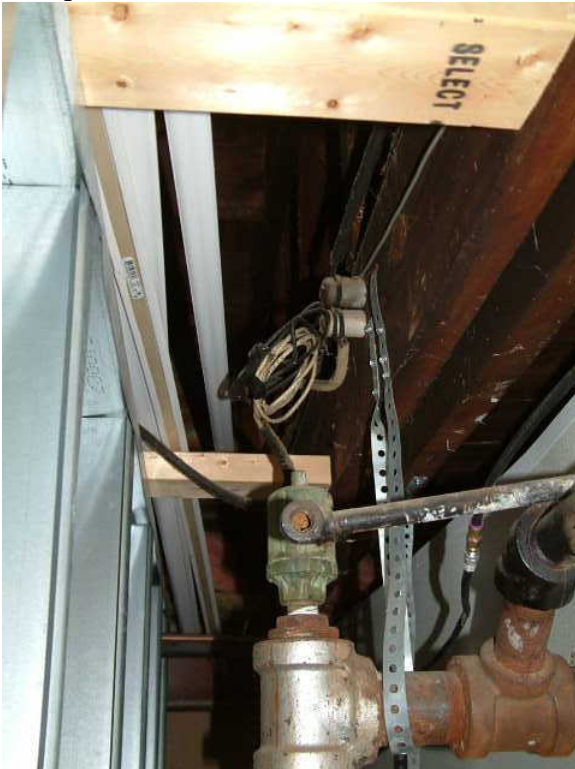
Basement: Any sheathed cable wiring that runs below the level of the bottom of the floor joists or outside the envelope of the wall studs should be in conduit for safety. In addition, any wiring that can be easily bumped, disturbed or accidentally cut should be in conduit for safety. The picture below shows wiring coiled behind the drywall in the southwest storage room. I recommend this should be properly secured by a competent and qualified electrician.

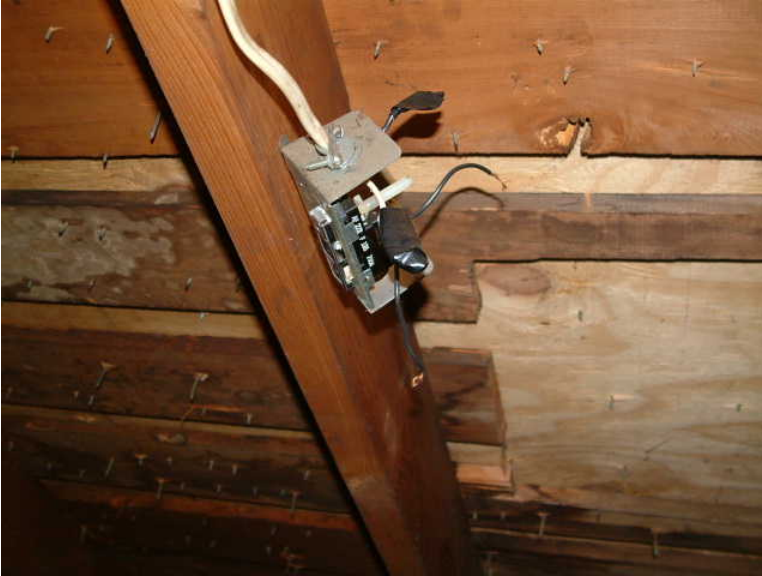
Condition of visible wiring (continued): *3rd floor/attic:* Electric wiring for the former exhaust fan in the attic has been left unprotected. I recommend it should be properly terminated in a sealed junction box. A competent and qualified electrician can do this work.

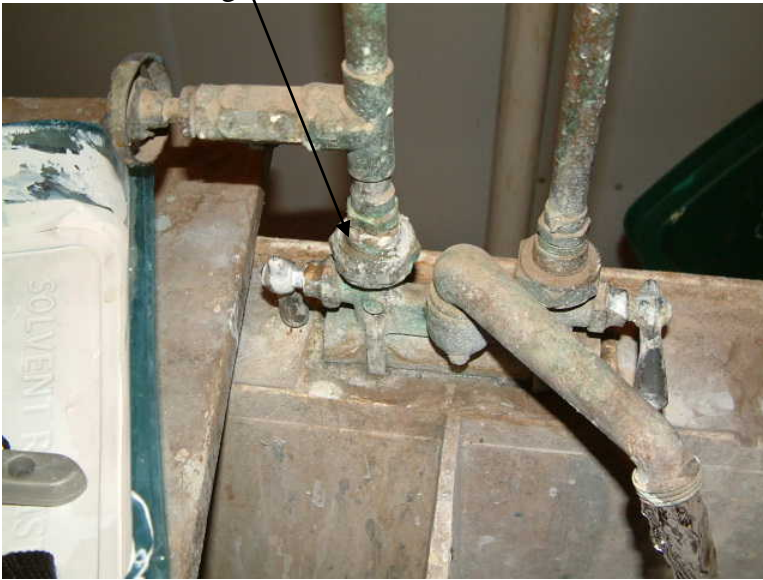
Interior Piping (continued): *Basement:* The sink faucet in the water heater room in the basement is leaking on the left side fitting.

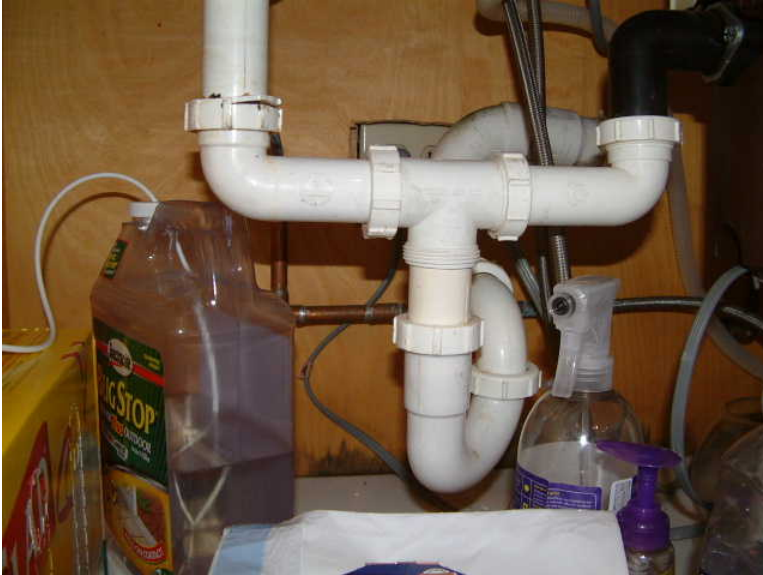
1st floor: The picture below shows the sink drain piping underneath the kitchen sink. The compression nut on the left down to is cracked and leaking. The compression nut at the bottom of the tee fitting is missing. I recommend that this drain piping should be reworked. The sink drain piping underneath the kitchen sink, shown in the picture below, is located below the tailpipe section that penetrates the rear wall of the sink cabinet. This means that the sections of pipe below the tailpipe are always filled with water. There are many joints and fittings in this arrangement that could begin to leak and cause water damage. I recommend that the piping should be reworked by a competent and qualified plumbing contractor to raise these sections of pipe above the tailpipe and reduce the number of connections and fittings to a minimum.

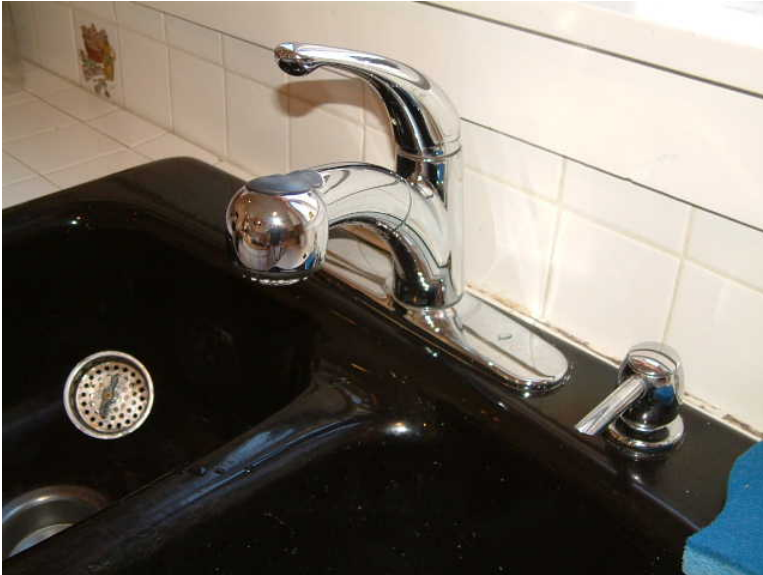
Interior Piping (continued): 1st floor: The kitchen sink faucet is loose on the sink.

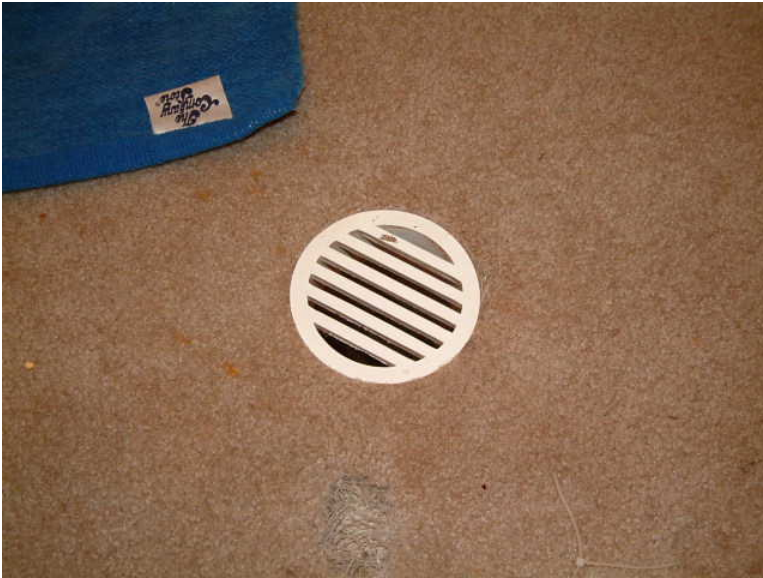
Floor drains/sewer cleanouts (continued): I recommend that this drain cover located in the middle of a recreation room floor should be replaced with a tight fitting grate to help prevent rodents from entering the house.

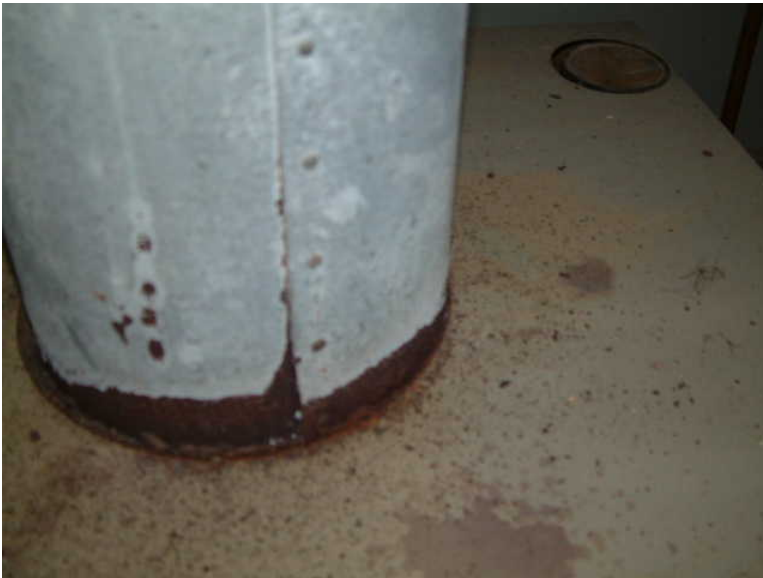
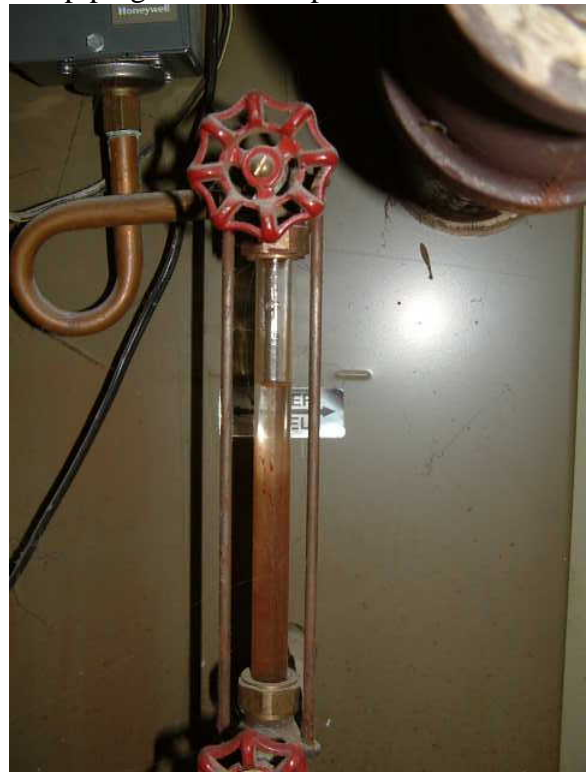
Condition: The boiler appears to be in good condition. No evidence of dry firing (heating the boiler without water in it) was seen. No carbon monoxide or gas leaks were detected at the time of inspection. The flue draws combustion gasses up the chimney well. However, the left side picture below shows the flue piping at the top of the furnace casing to be very rusty. I recommend that the flue piping should be replaced.

The right side picture above shows the water level in the sight glass. I recommend that the boiler should be serviced before the next winter so that the water levels can be properly set and the boiler and burners cleaned. The water level was too high in the boiler at the beginning of the inspection.

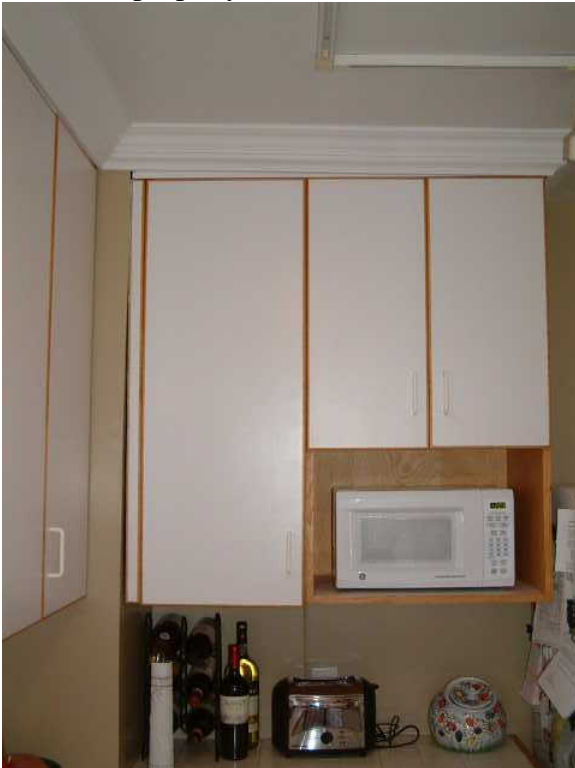
Cabinets: The cabinets appear to be in fair condition. The doors swing easily and smoothly. However many loose and sagging doors were found at the time of inspection. They need to be tightened with a screwdriver. The picture below shows the cabinets at the northeast wall of the kitchen to be sagging. I recommend that these should be properly reattached to the wall. A competent and qualified carpenter can do this work.

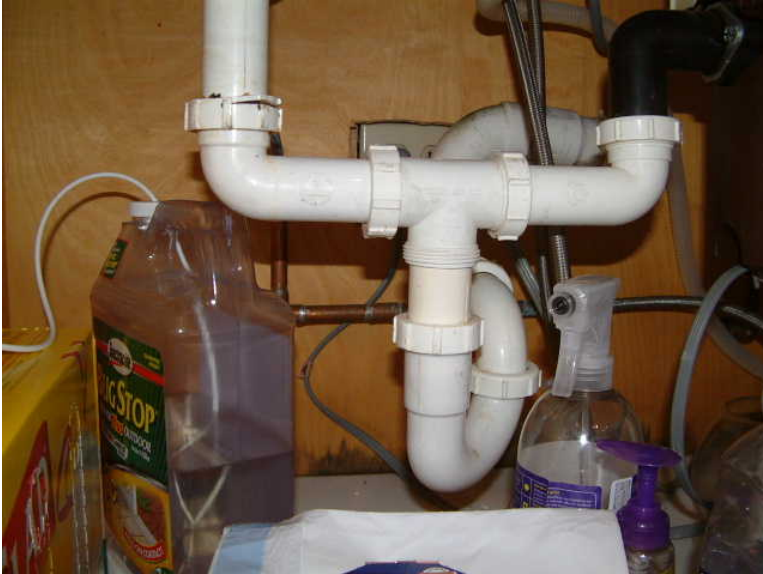
The picture below shows the sink drain piping underneath the kitchen sink. The compression nut on the left down to is cracked and leaking. The compression nut at the bottom of the tee fitting is missing. I recommend that this drain piping should be reworked. The sink drain piping underneath the kitchen sink, shown in the picture below, is located below the tailpipe section that penetrates the rear wall of the sink cabinet. This means that the sections of pipe below the tailpipe are always filled with water. There are many joints and fittings in this arrangement that could begin to leak and cause water damage. I recommend that the piping should be reworked by a competent and qualified plumbing contractor to raise these sections of pipe above the tailpipe and reduce the number of connections and fittings to a minimum.

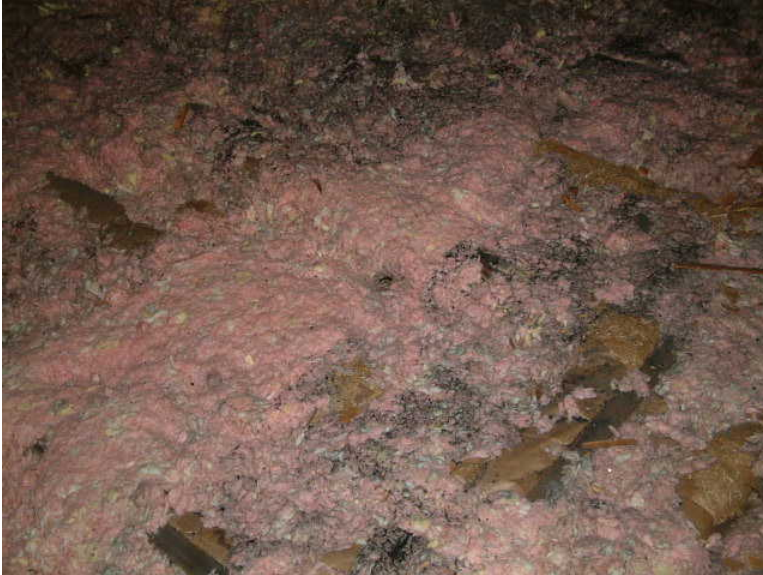
Insulation: Shredded fiberglass insulation has been placed on the "floor" of the attic. The insulation is approximately 5 inches deep. I recommend that additional insulation should be installed for energy efficiency. Total insulation depth should be approximately 12 to 13 inches.

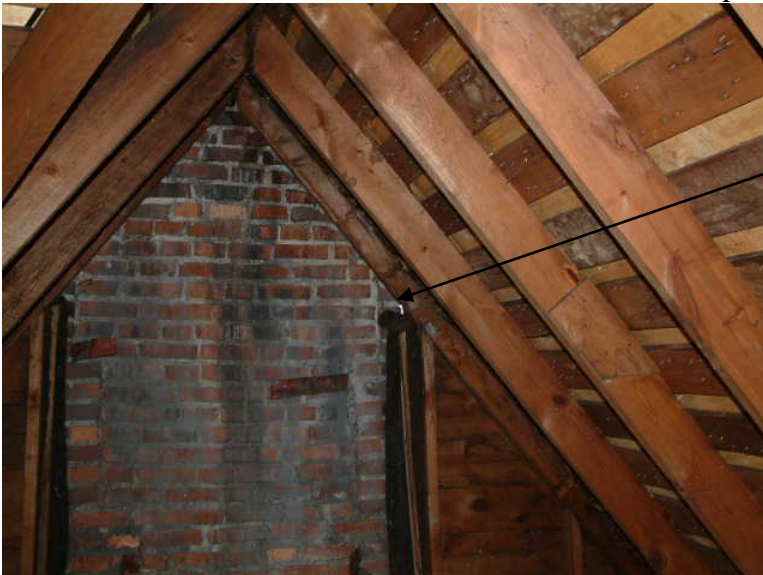
The picture below shows daylight coming into the attic at the joint between the chimney and siding on the front of the house. I recommend that this should be sealed to prevent birds or bats from entering the attic.

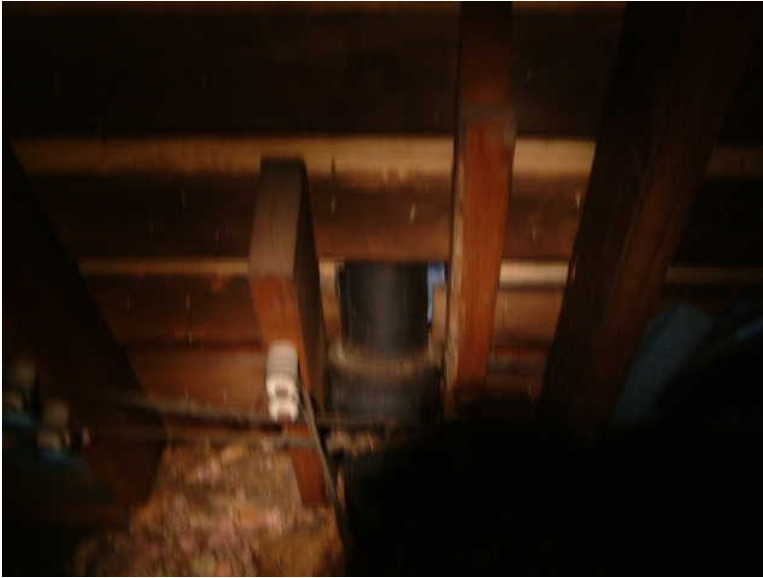
Framing (continued): Daylight was seen around the Northwest plumbing stack. No evidence of leaking was seen. I recommend that this should be properly re-flashed by a competent and qualified roofing contractor.

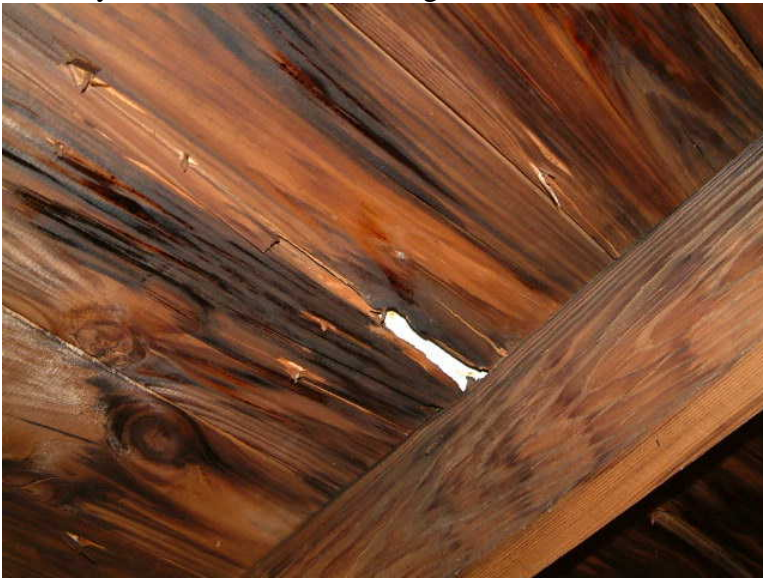
The picture below shows deteriorated roof decking underneath the flat deck roof. This should be checked annually for science of continuing deterioration.

Consideration should be given to installing a hatch through the flat deck.

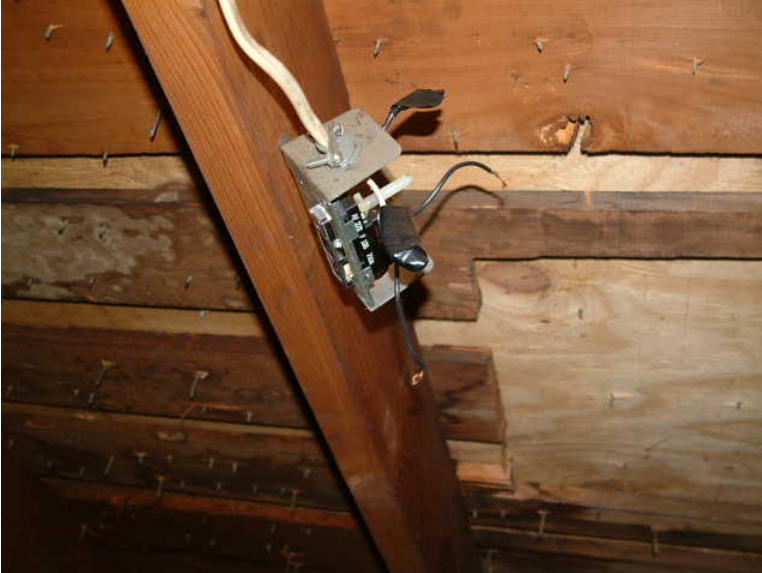
Electric wiring for the former exhaust fan in the attic has been left unprotected. I recommend it should be properly terminated in a sealed junction box. A competent and qualified electrician can do this work.

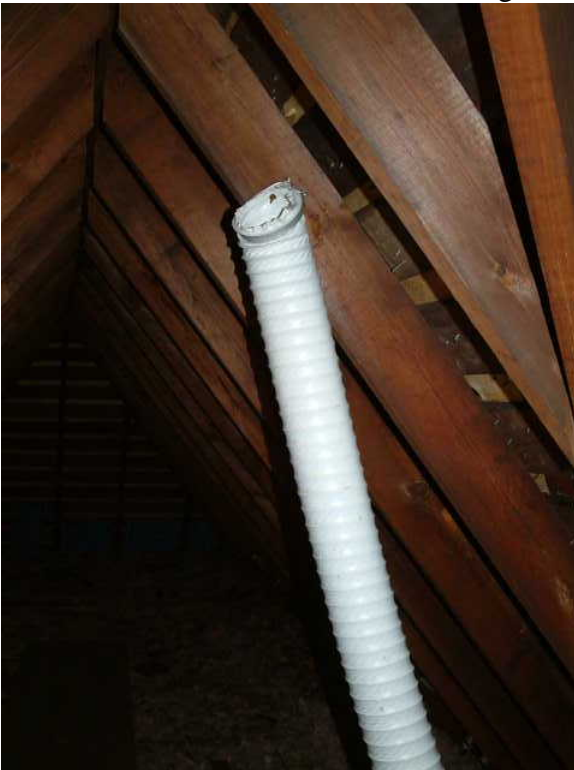
The picture below shows the north bathroom exhaust fan discharging into the attic. I recommend that this fan should be directed to the exterior through a wall or roof to help prevent condensation in the attic.
