Western Reserve Home Inspection LLC

Address of house:

Age of house: Built in 1925; the house is 84 years old.

Type of house: 2 story wood frame.

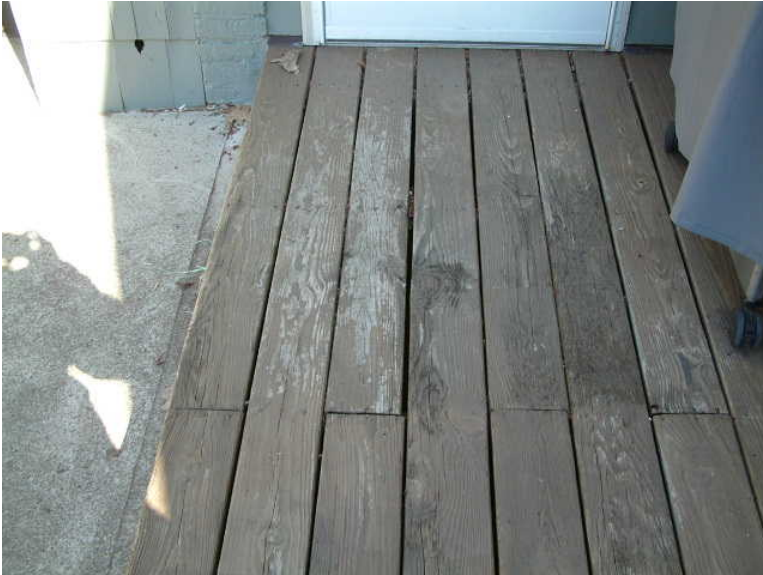
Patios/Decks: The deck outside the southwest wall of the house is in good structural condition. However, the deck boards need to be scraped and recoated with paint or stain to retard weathering of the wood.

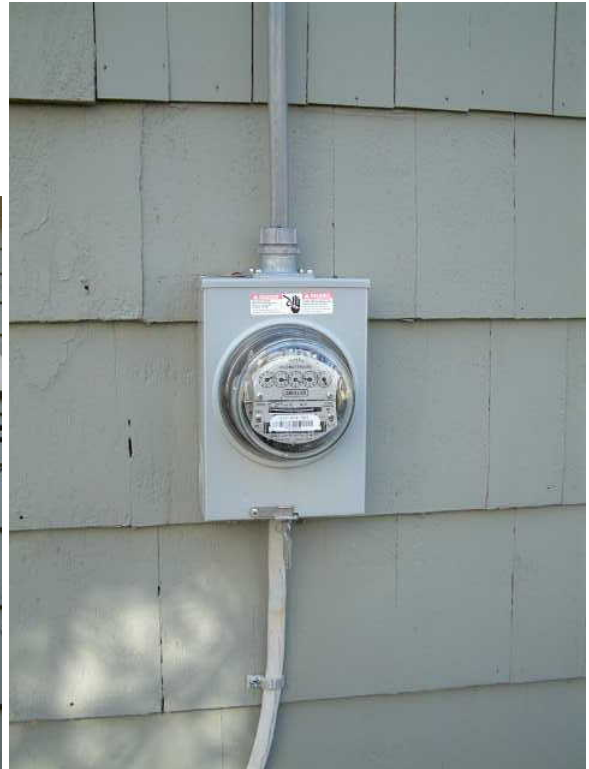
The right side picture above shows the electric service entrance mounted on the northwest wall. It appears to be in good condition and is firmly anchored.

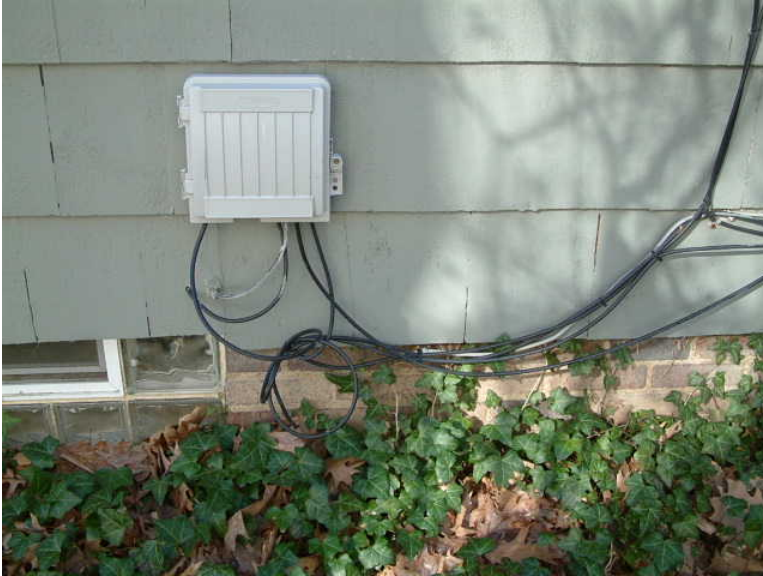
Water/Gas/Electrical/Telephone/Television service (continued): The left side picture below shows the TV cable and data services entrance mounted on the northwest wall. It appears to be in good condition and firmly anchored. The right side picture below shows the telephone service entrance mounted on the northwest wall. It is in good condition.

Consideration should be given to rationalizing the television and telephone wires mounted on the northwest wall.

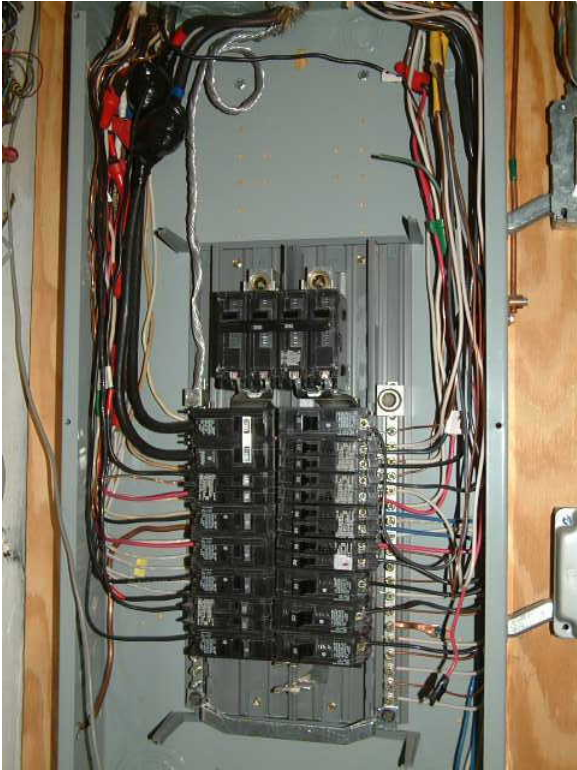
Service panel: The main panel and circuit breakers are in good condition. A 200 amp main circuit breaker has been installed in this panel that can be used if the power service is upgraded.

No electric hazards were seen in the main panel at the time of inspection.

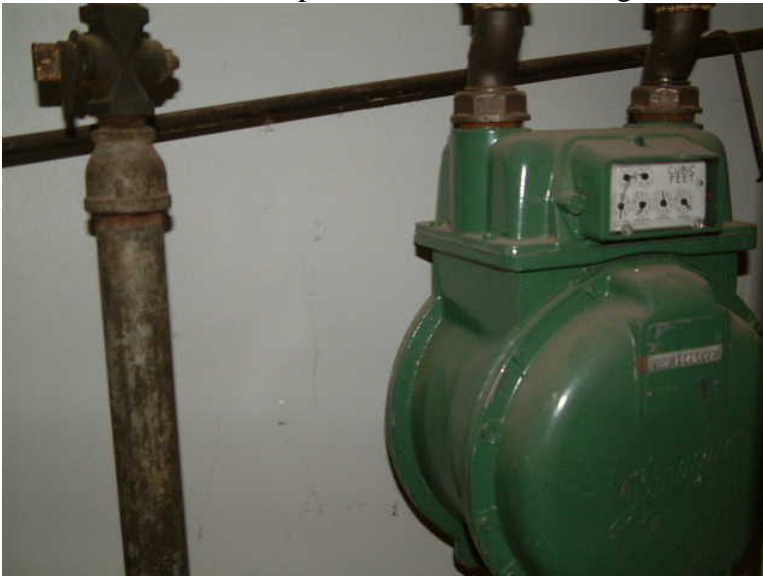
Basement: The picture below shows the gas meter.

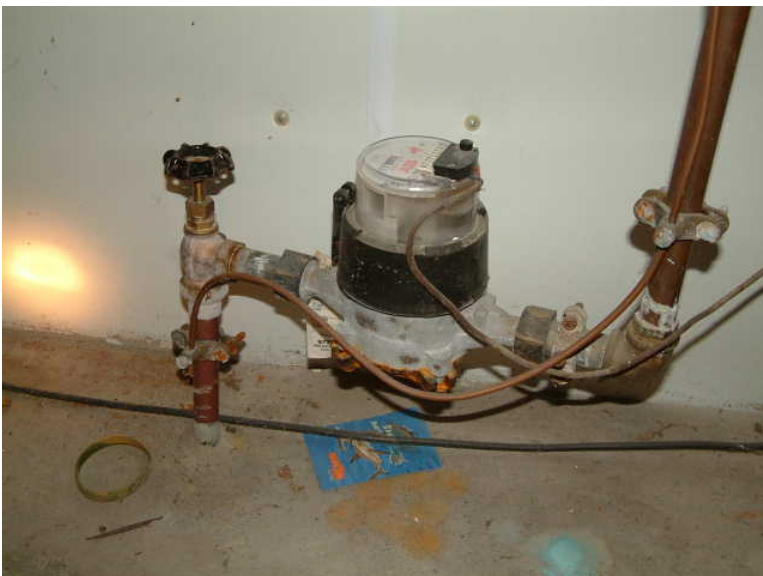
The picture below shows the water meter. The water and gas meters are accessible through panels in the northeast wall of the basement.

Water pressure: The water pressure was tested at 100 pounds per square inch at the time of inspection. I recommend that a pressure regulator should be installed on the cold water piping above the water meter to reduce the pressure to approximately 65 to 80 pounds per square inch. Reducing water pressure will help to save automatic valves, valve fittings and hoses that are plastic or rubber. Continuous high-pressure on valve components will permanently stretch or disfigure them over time leading to failure of the valves. High pressure on hoses will eventually burst the hoses. A competent and qualified plumbing contractor can do this work.

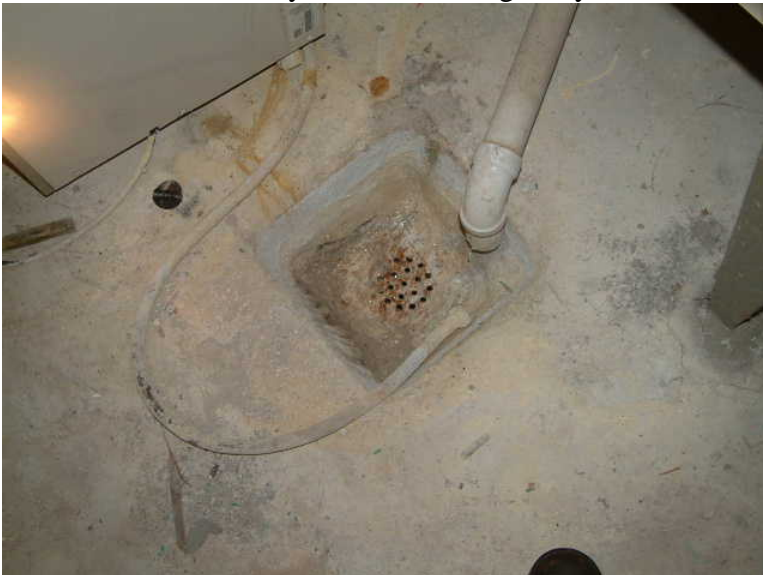
Floor drains/sewer cleanouts: There are floor drains in the water heater room and the recreation room of the basement. A bucket of water should be poured into these drains at a minimum of every month to keep the traps filled with water if they are not used regularly.

Floor drains/sewer cleanouts (continued): I recommend that this drain cover located in the middle of a recreation room floor should be replaced with a tight fitting grate to help prevent rodents from entering the house.

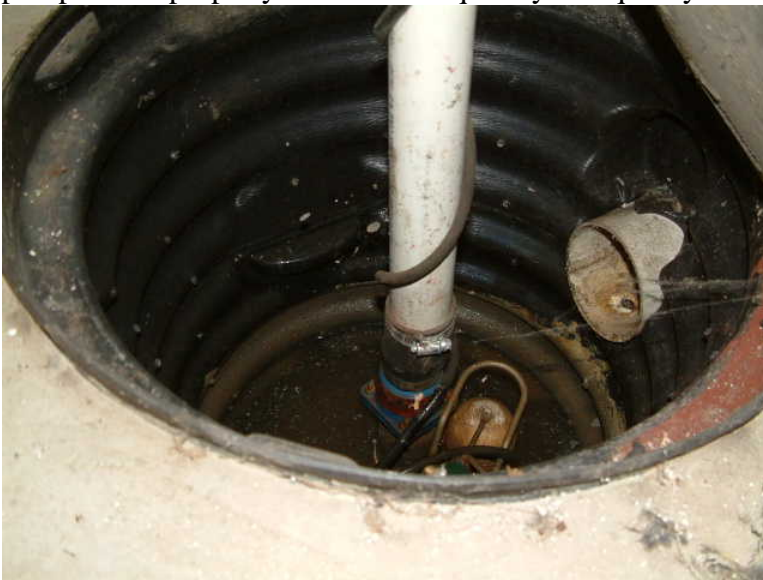
The picture below shows the sump pit located behind the wall at the east corner of the basement. The sump pump works properly and drains it quickly and quietly.

Consideration should be given to purchasing an emergency power supply for the sump pump and to purchasing a reserve sump pump.
